Safe at Home Inspection Service LLC

HOME INSPECTION REPORT

4413 Madeira Rd
Pleasant Hill, CA 94123

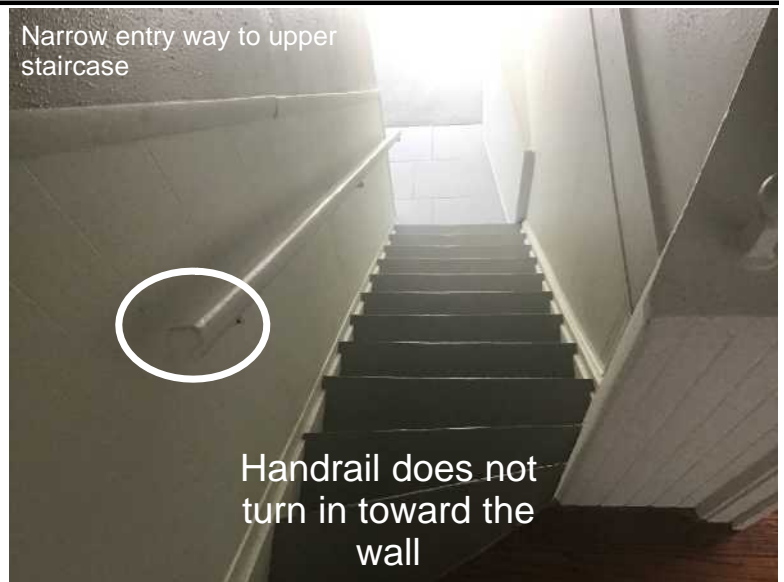
1. Stairs (Interior): Wood stairs with wood handrails - Handrail needs to turn in toward the wall at the top of the stairs. With no elbow at the top (turned into the wall), this is considered a trip/fall hazard, as purses, dresses and other loose items can become caught on the rail and cause a person to fall. Recommend installation of an elbow so that the rail end turns into the wall and meets it flush.

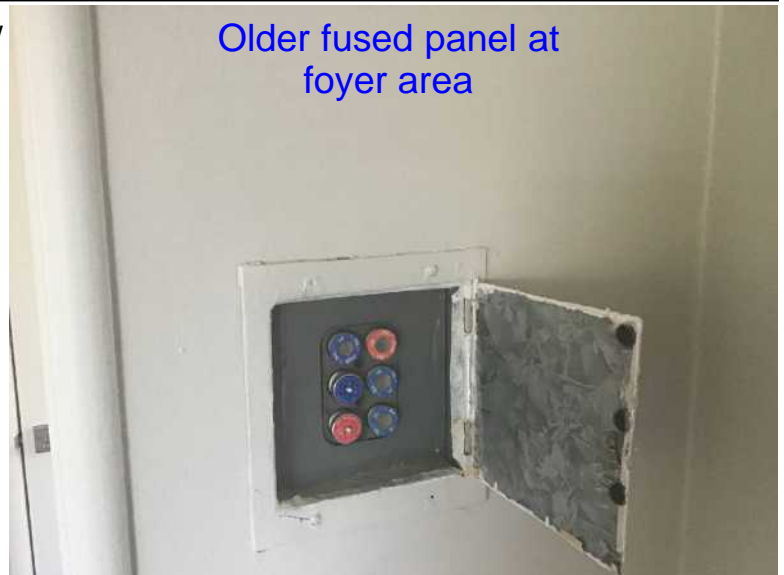
2. Recessed in wall, Foyer Electric Panel Fuses: Screw type - The wiring/electrical components are currently being protected by fuses rather than circuit breakers. Fuses are no longer used for this type of protection and this panel should ultimately be upgraded to included circuit breaker protection in order to comply with current industry standards.

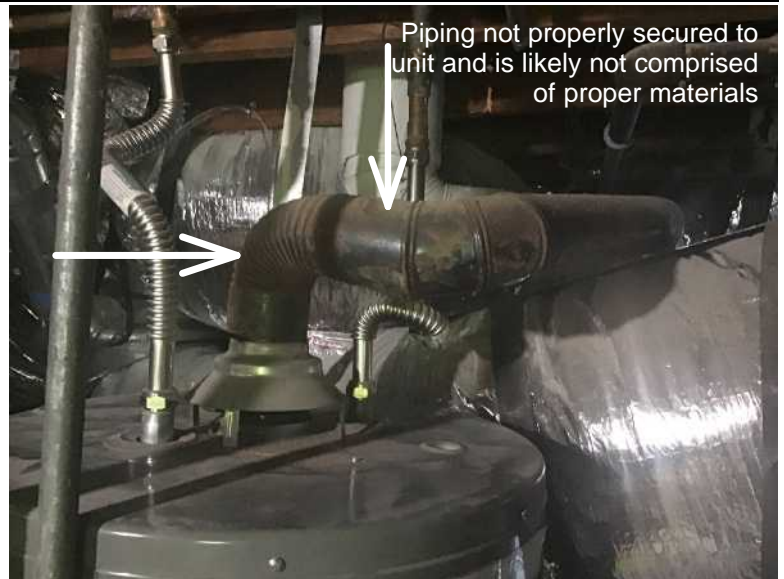
3. Crawl space Water Heater Flue Pipe: Metal - The piping is not properly secured to the top of the unit and also appears to not be of galvanized steel double wall material, commonly called upon the current industry standards. Recommend replacing the pipe with a properly rated one and having it properly secured to the unit.

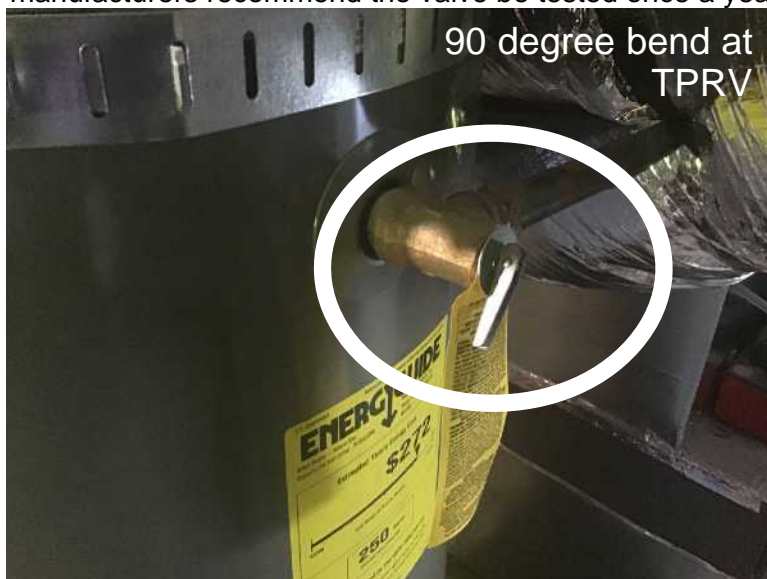
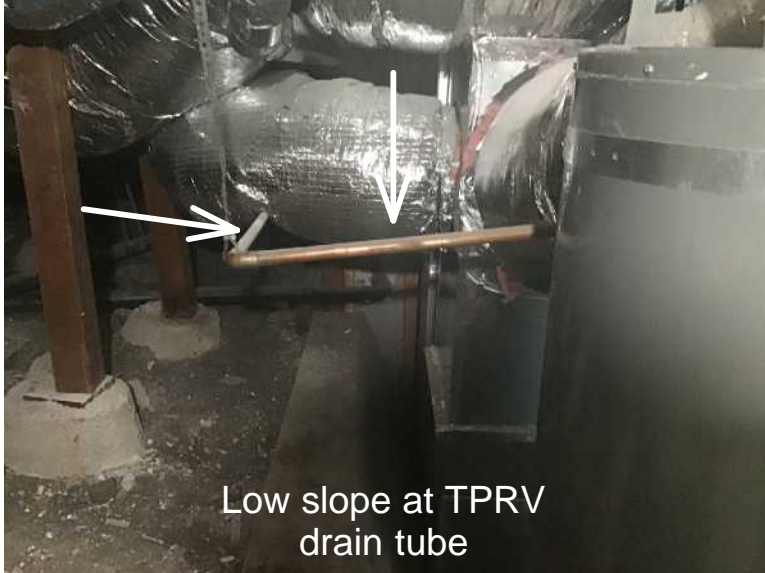
4. Crawl space Water Heater TPRV and Drain Tube: Copper - The TPRV currently takes a 90 degree bend shortly after leaving the unit. Its drain tube also has a very narrow slope exiting toward the exterior of the home. Recommend that this piping face directly downward and terminate within 6 inches of the crawl space floor.

A temperature and pressure relief valve (TPRV) is a safety valve that releases excess pressure from the water heater in the event the regulator fails. It is an important safety device that can prevent a dangerous explosion. Hot water may occasionally drip or spray from the valve discharge pipe, triggered by changes in water pressure. Leaky valves may fail from encrusted mineral residue, and should be replaced. Most TPRV manufacturers recommend the valve be tested once a year.

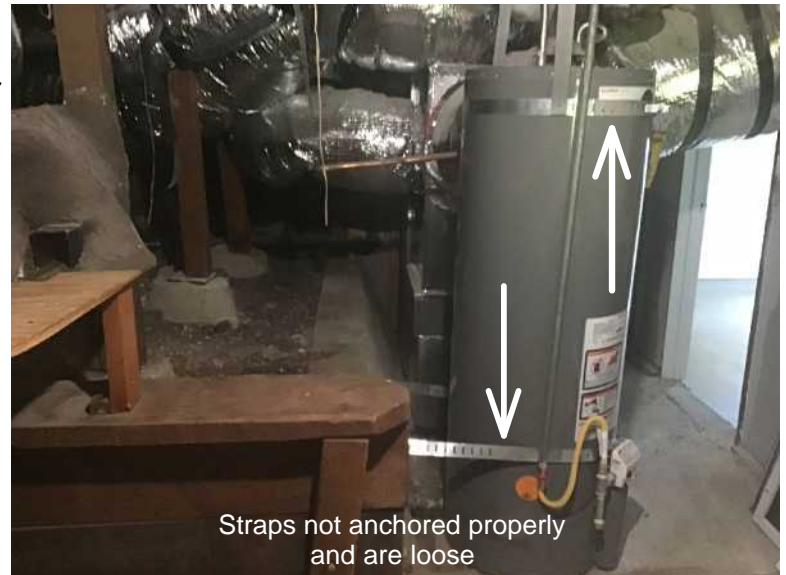
5. Crawl space Water Heater Seismic bracing Water heater is properly braced in accordance with current CA industry standards - Seismic straps at the water heater are not currently anchored in accordance with current industry standards. They should be re-situated so as to anchor into adjacent wood framing members. These straps are also slightly loose and are in need of tightening since the unit does wobble excessively with moderate force. The straps should be tightened or re-situated so that the unit will not wobble in the event of an earthquake.

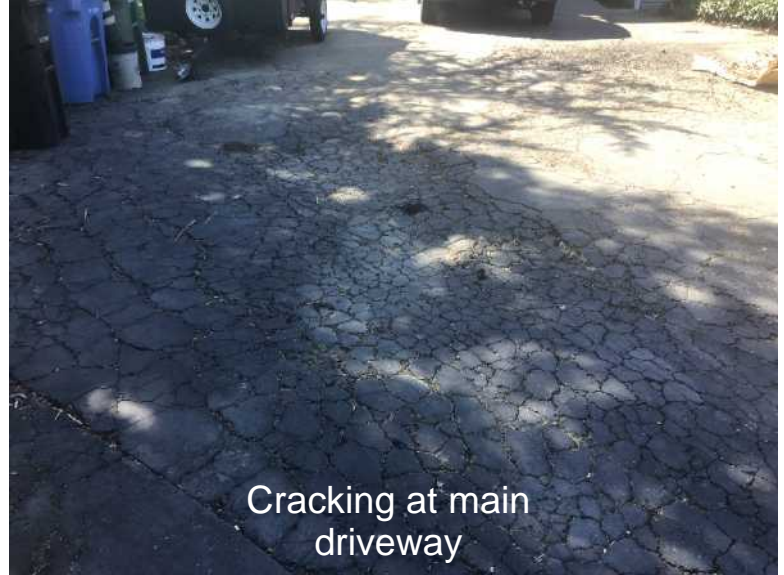
Driveway: Asphalt - Typical cracking and settling for a driveway of this type, slope and age. Recommend monitoring over time and eventual evaluation by a qualified contractor if cracking gets worse going forward.

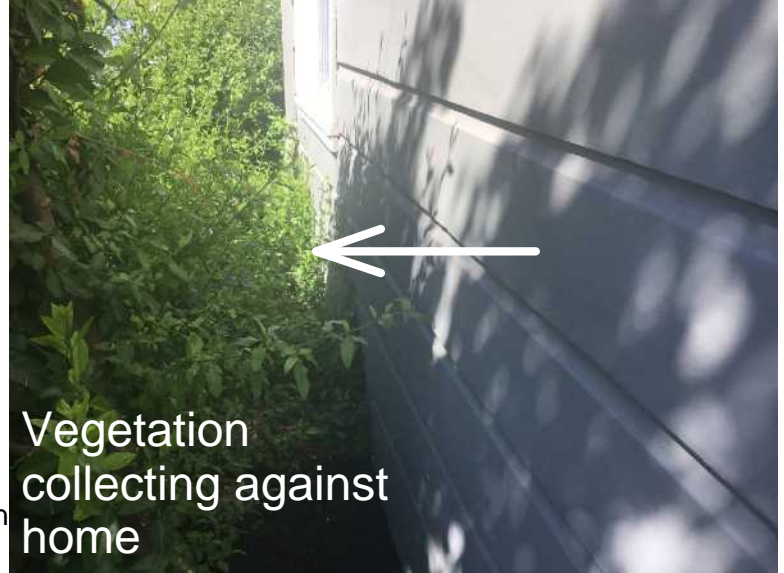
Vegetation: Trees, Shrubs - Recommend trimming all vegetation away from home. Constant contact between vegetation and home's siding can hasten the deterioration of the siding and reduce it's life expectation. Over time, this can also allow for water and/or pest entry. Preventative maintenance can be taken by keeping all vegetation away from the siding and all roots away from the home's foundation.

Recommend trimming all trees back away from the roof area. Leaves/debris collecting on the roof can cause premature deterioration of the shingles and roof components. Heavy branches may also become dislodged and fall on the roof, creating damage. Care should be taken to cut back all branches that hang over the roof.

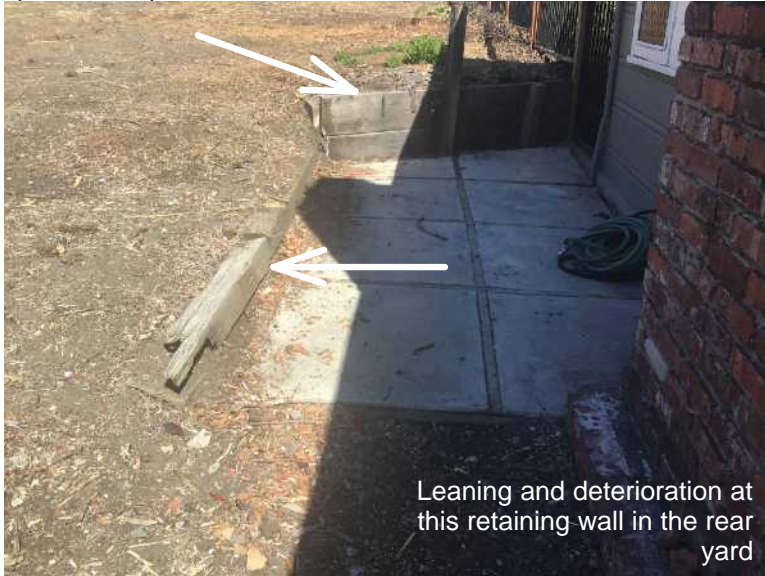
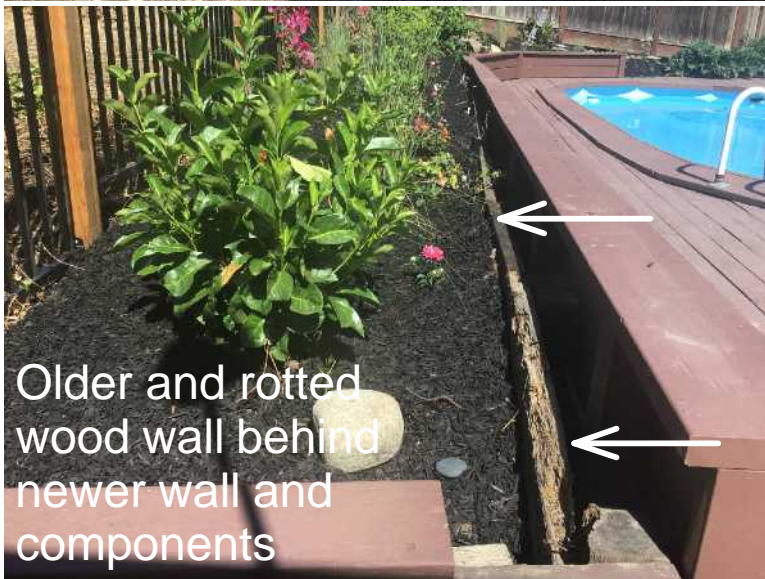
Retaining Walls: Wood - The retaining wall at the rear yard is beginning to lean due to the pressure of the earth that it is supporting. No action is required at this time but recommend monitoring this wall for further movement over time and having corrections made by a qualified contractor should repairs become necessary.

Older and rotted wood is being used at the original retaining wall at the rear side of the pool. A new wall has been built outside of the old wall, but please note that the old wall is still present. No action is required at this time but it should be expected that the original wall will fail over time.

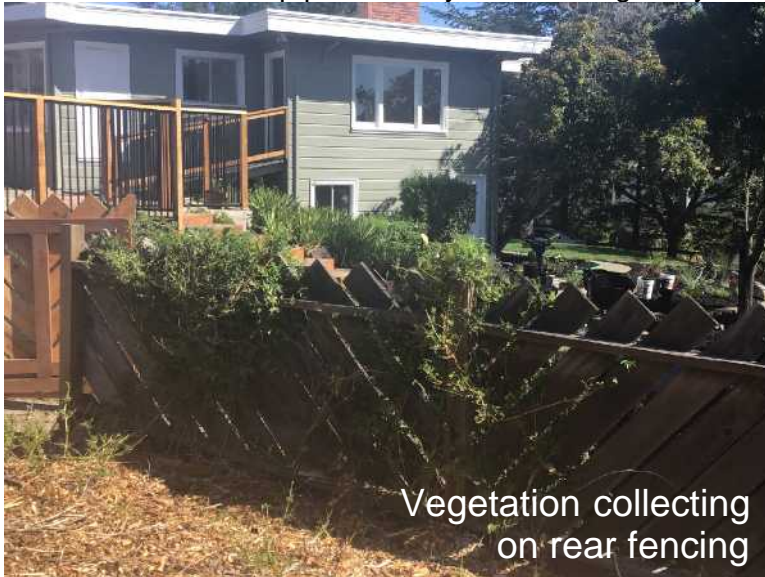
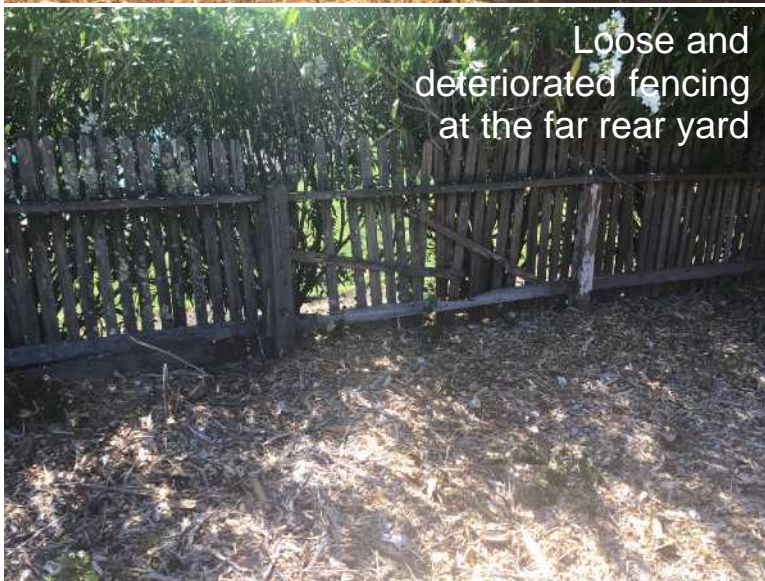
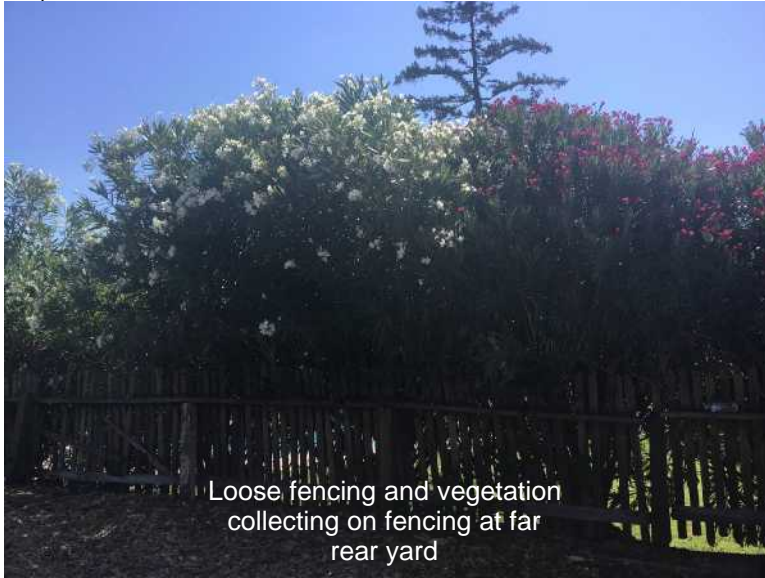
Rec. Evaluation Fences: Wood (at rear yard), Wood with metal wire, Metal rail - Sections of the fencing are damaged/deteriorated at the far rear yard. Recommend that any damaged areas be repaired.

Sections of the fencing are loose and should be re-secured going forward.

The vegetation is growing over the fencing in places and should be removed or trimmed back so that it does not end up prematurely deteriorating away the fencing components over time.

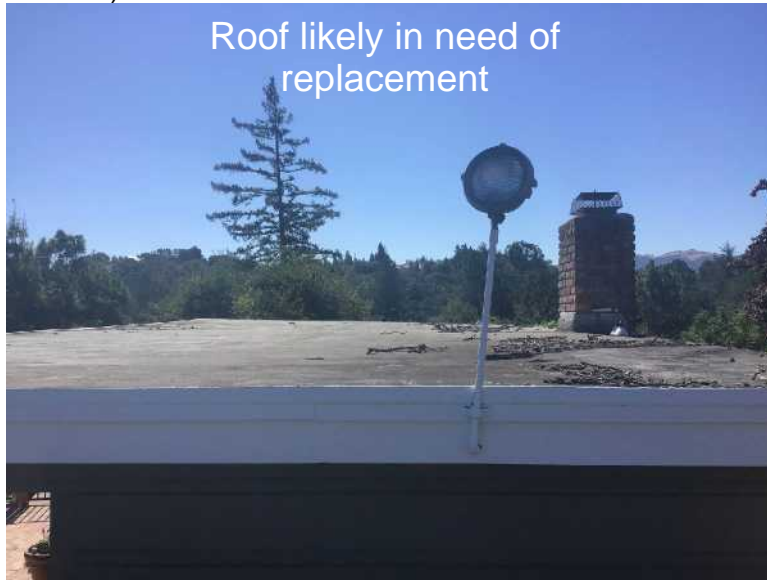
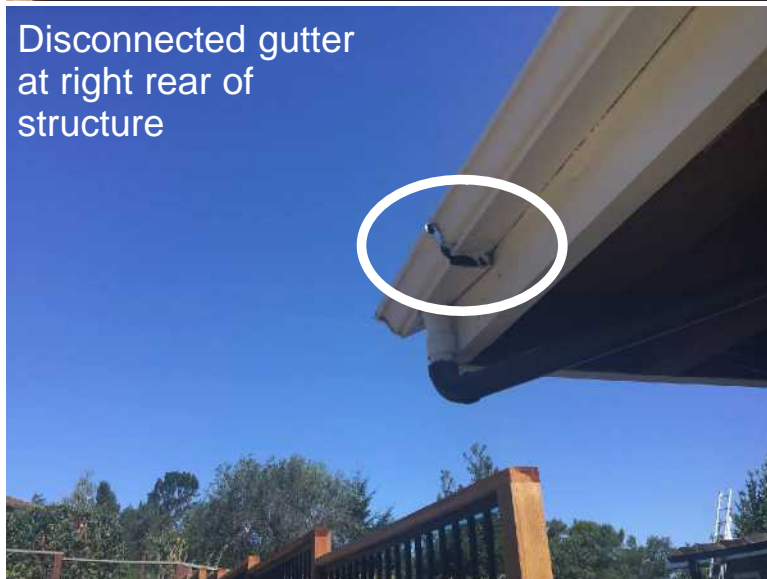
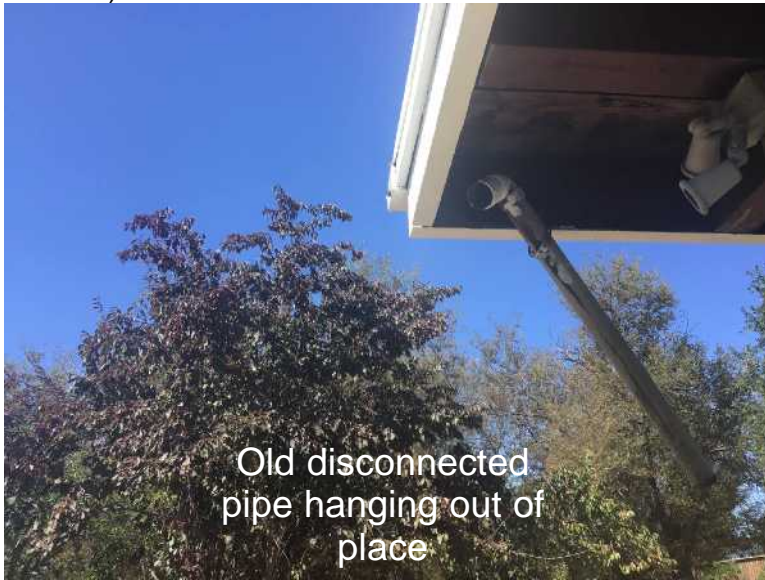
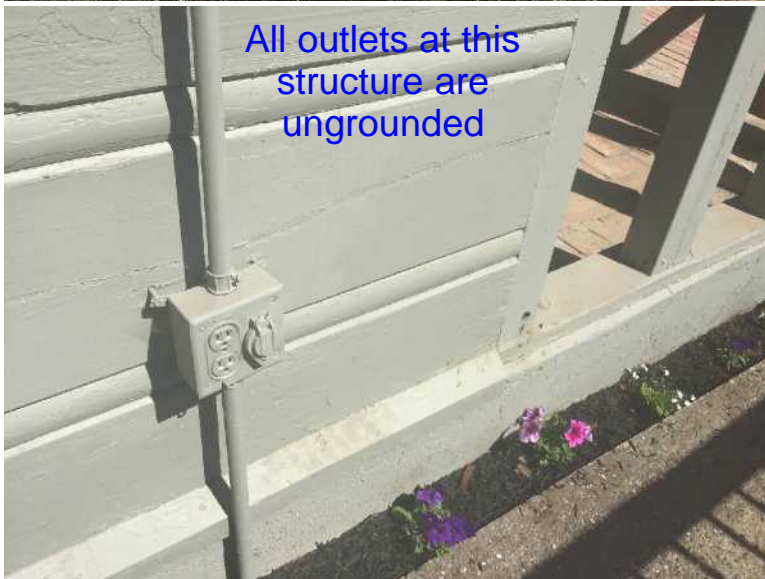
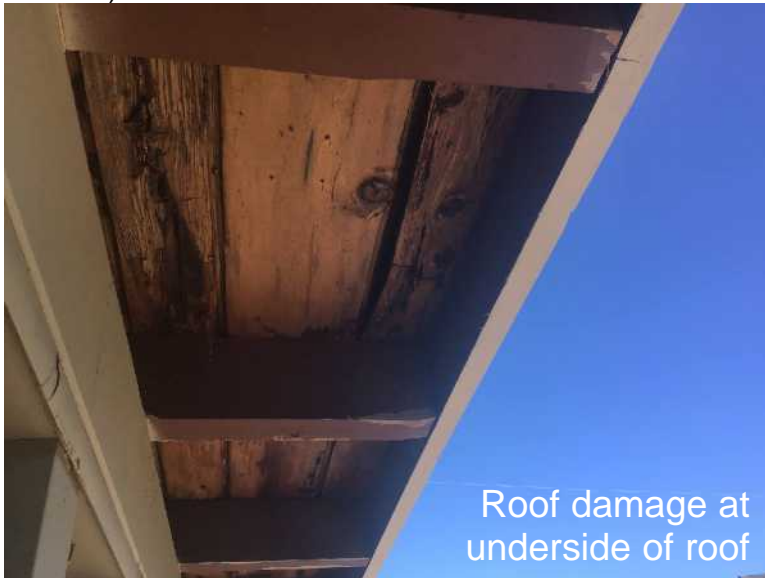
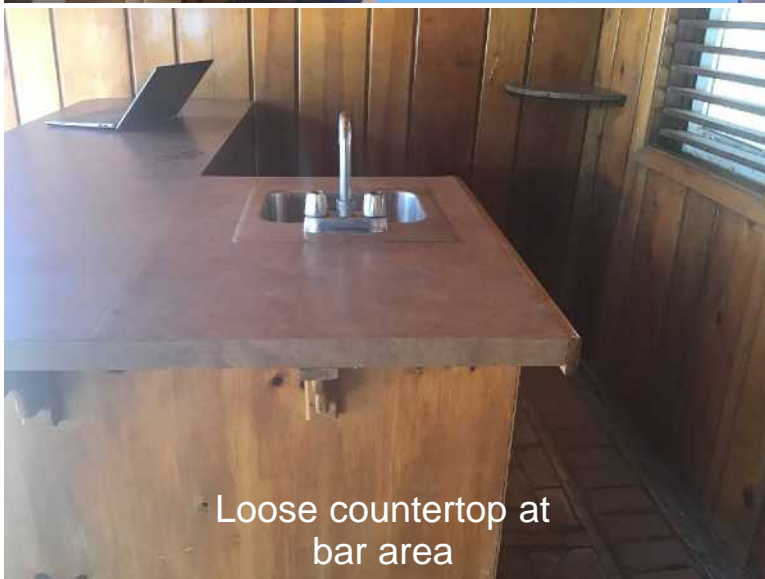
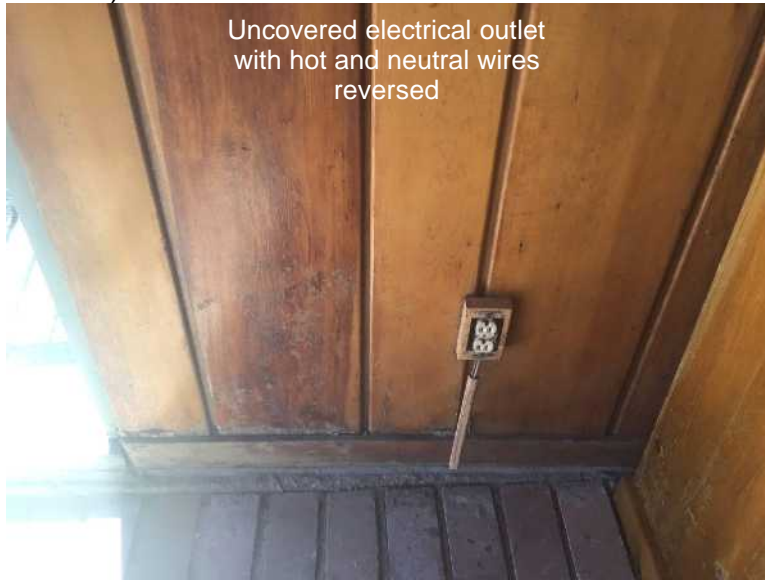
- The flat roof appears to have reached the end of its typical life cycle and should be replaced.
- The disconnected section of gutter at the right rear corner of the structure
- The old hanging section of piping at the left rear corner
- The loose countertop at the bar
- Ungrounded electrical outlets
- The uncovered electrical outlet with the hot and neutral wires reversed

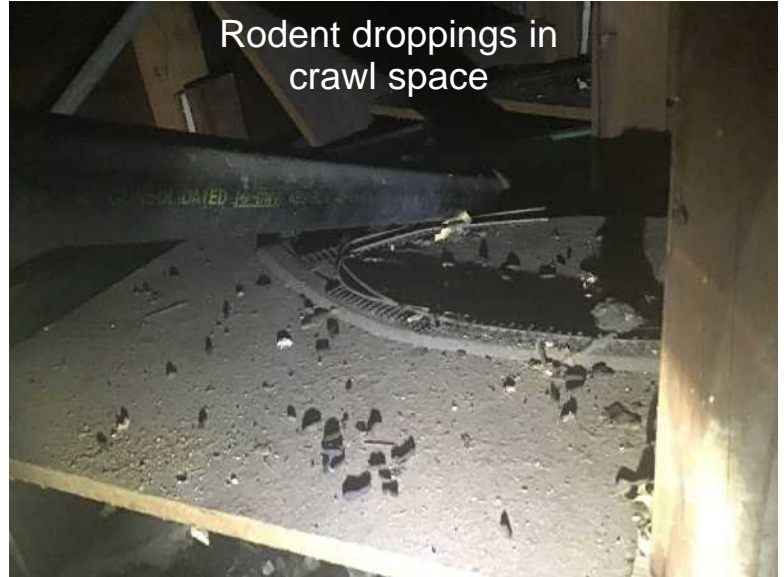
Rec. Evaluation Evidence of Pests: Rodent droppings observed - Moderate amounts of rodent droppings were observed in the crawl space area. Recommend following the advice of the recent past inspection report as to the proper course of action relating to these droppings.

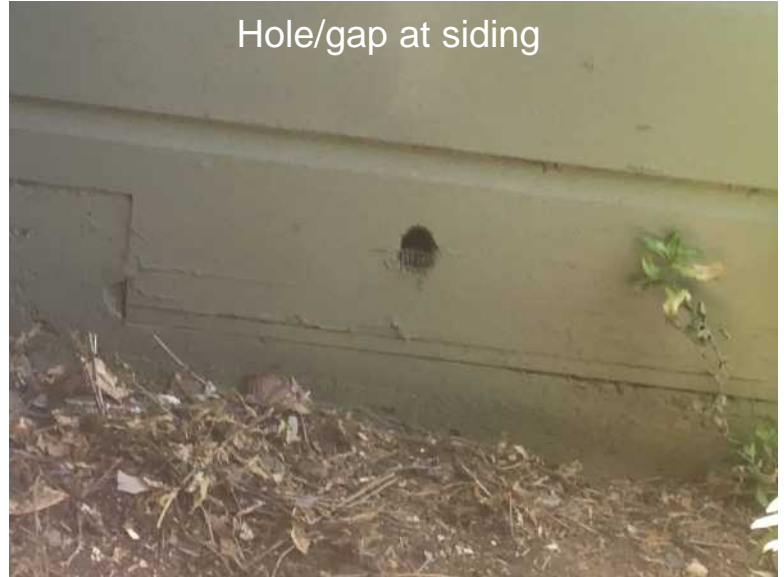
Rec. Evaluation Siding Wood siding - There was cut out siding noted at the rear of the home. Recommend that this area be filled and sealed and re-painted or that he screams be installed so as to protect against potential pest entry.

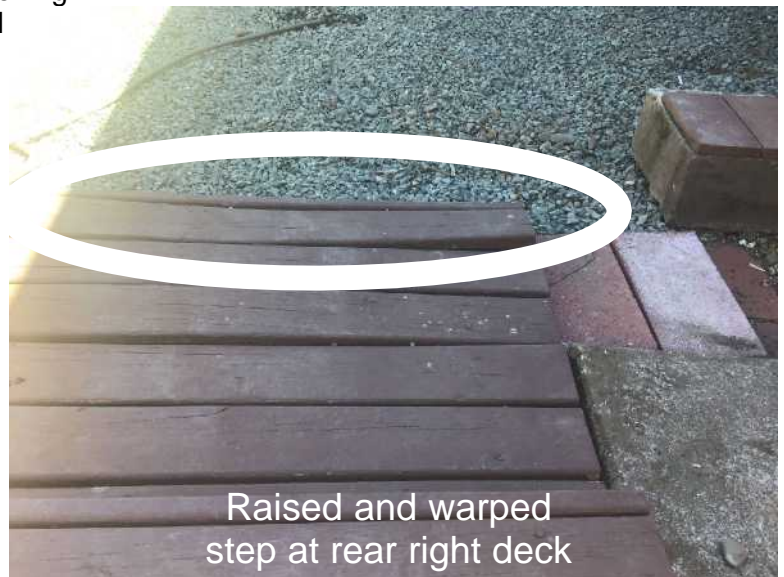
Structure Type: Wood frame
Trim: Wood, Metal, Brick
Fascia: Wood
Soffits: Metal frame at eaves (screened in)
Windows: Metal sliding, Wood, Non opening
Stairs/Steps: Concrete stairs with metal handrails, Metal stairs with wood handrails - The bottom step at the deck at the right rear of the home is warped and raised and is currently acting as a potential trip/fall hazard. Recommend using caution when using this area and ultimately having this board replaced.

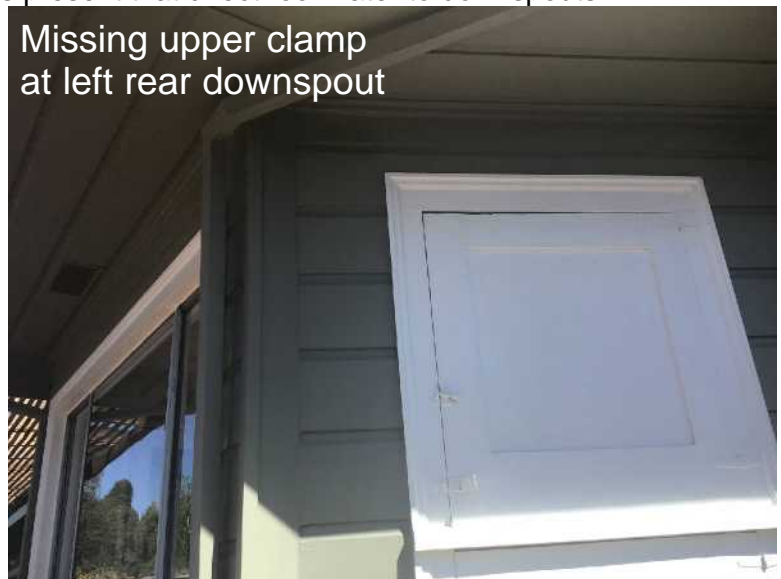
Not Present	Gutters: No gutters (flat roof). Scuppers present that direct roof water to downspouts.
Rec. Evaluation	Downspouts: Metal (painted over), Plastic - Loose or missing clamps noted at the downspout at the left rear of the home. Recommend that any missing or loose clamps be re-secured to the home going forward.

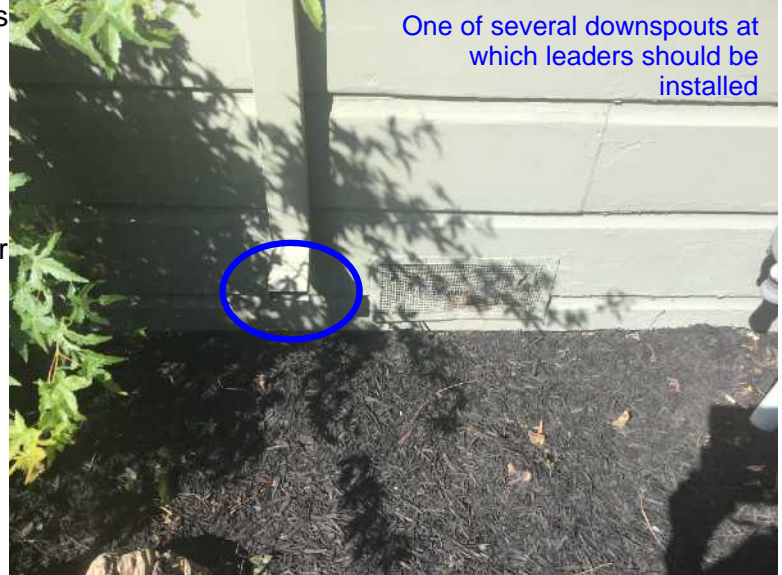
Left rear of home Chimney

Acceptable, Not Present Leader/Extension: Downspouts routed to underground drainage, None in places - Missing leader/s noted at some areas of the home. Recommend that leader/s be installed where needed in order to promote positive water drainage.

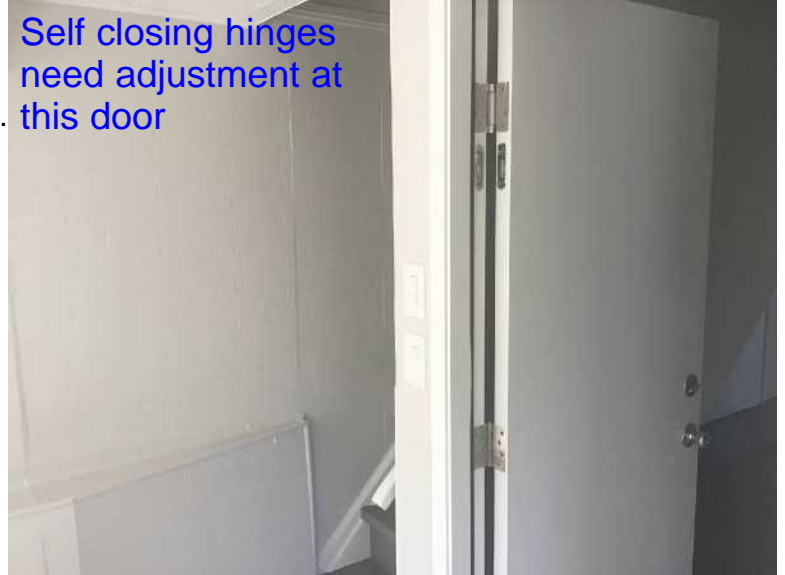
Please note that the middle hinge at the door is not self closing and a third self closing hinge can also be added here in order to mitigate this condition. This type of door should fully close/latch on its own in order to meet current industry standards.

Self closing hinges
need adjustment at
this door

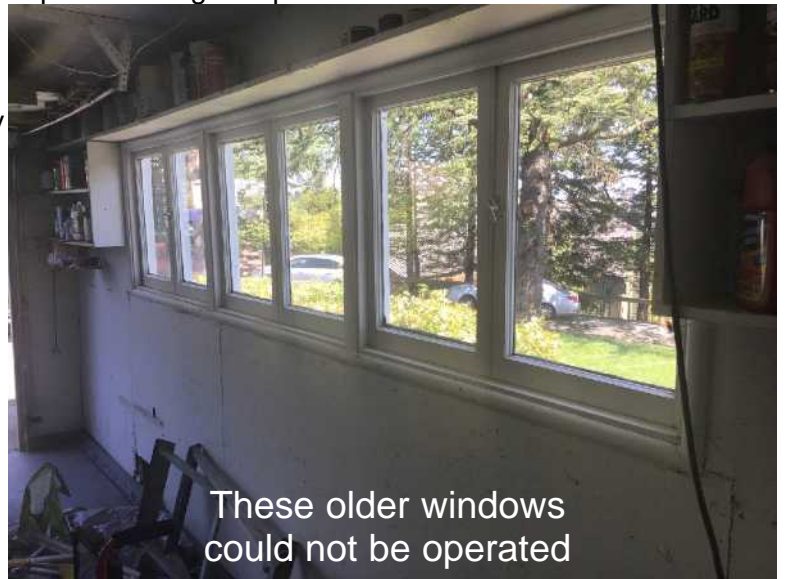
Miscellaneous: Older windows - The older wood framed windows at the garage were not able to be opened at this time. Recommend an evaluation by a qualified contractor if these windows are to be used to going forward.

These older windows
could not be operated

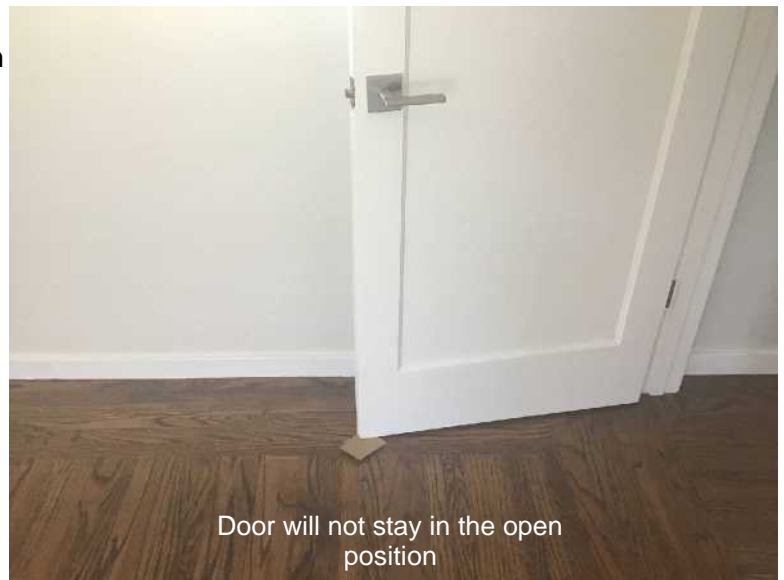
Acceptable	Closets: Walk In, Large, Single, Small
Acceptable	Ceilings: Drywall/plaster, Paint, Acoustic tile at lower bedroom
Acceptable	Walls: Drywall/plaster, Paint
Acceptable	Floors: Hardwood, Tile, Carpet
Rec. Evaluation	Doors: Sliding glass door, Wood, Sliding/pocket door, French, Wood with glass insert - The master bedroom door will not stay in the open position without beginning to close. Recommend adjustment of the door/hinges so that the door can remain in the open position, if desired.

Door will not stay in the open position

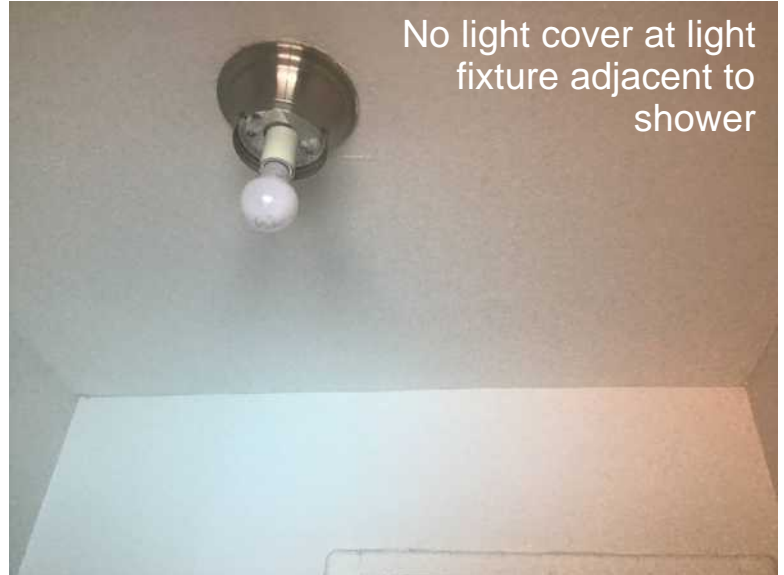
Rec. Evaluation Interior Lighting: Chandelier, Track lighting, Wall lamps, Overhead/Ceiling mounted - The overhead light at the shower is missing its cover. A cover is required at this location in order to protect against moisture making contact with a hot bulb and causing the bulb to shatter. A new cover should be installed at this location going forward.

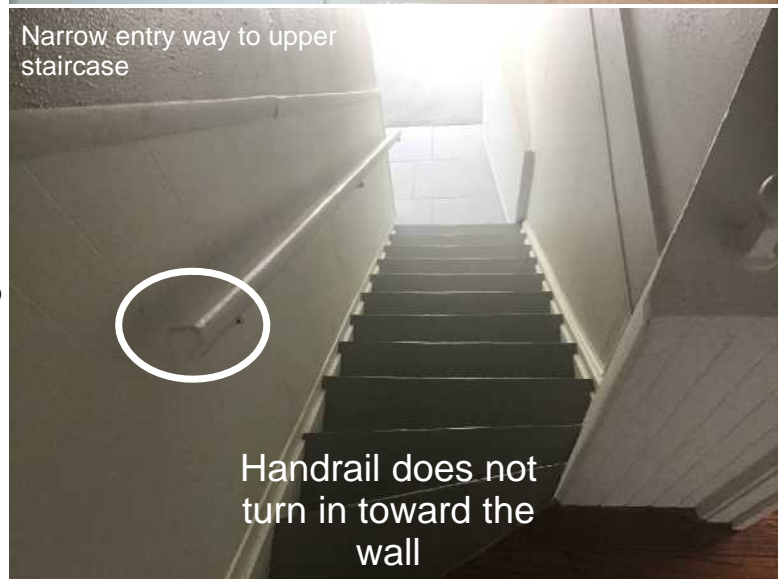
Marginal Stairs (Interior): Wood stairs with wood handrails - Handrail needs to turn in toward the wall at the top of the stairs. With no elbow at the top (turned into the wall), this is considered a trip/fall hazard, as purses, dresses and other loose items can become caught on the rail and cause a person to fall. Recommend installation of an elbow so that the rail end turns into the wall and meets it flush.

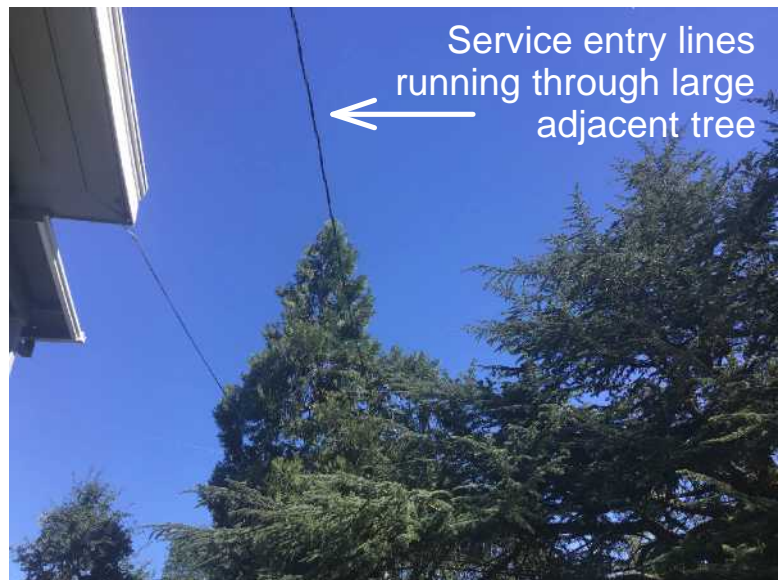
Service Entrance: Above ground from pole to masthead - The service entry lines are currently passing through a large tree. While no issues were observed at the inspection, it is not known how the adjacent limbs may grow/potentially interfere with the lines going forward. The local power company will come out and evaluate whether trimming is necessary, free of charge...and should be consulted, if desired going forward.

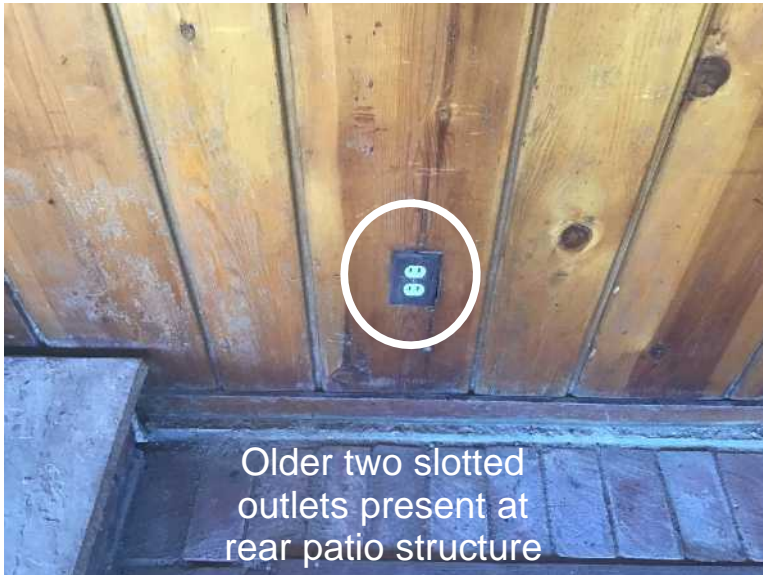
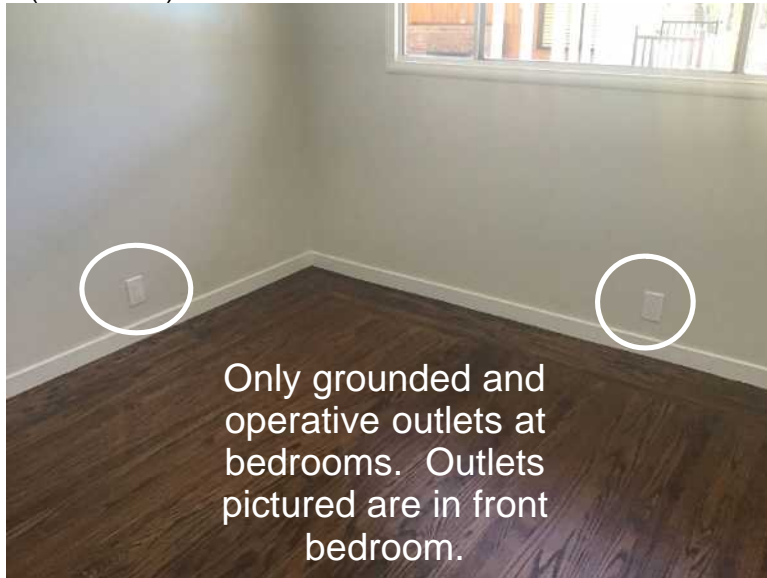
Outlets throughout the home are ungrounded. These outlets are largely concentrated at the bedroom and the front living room. There is also one on grounded outlet at the kitchen next to the large window facing the rear yard and at the lower bedroom in front of the staircase. Recommend evaluation by qualified contractor to determine proper course of action to properly ground all outlets.

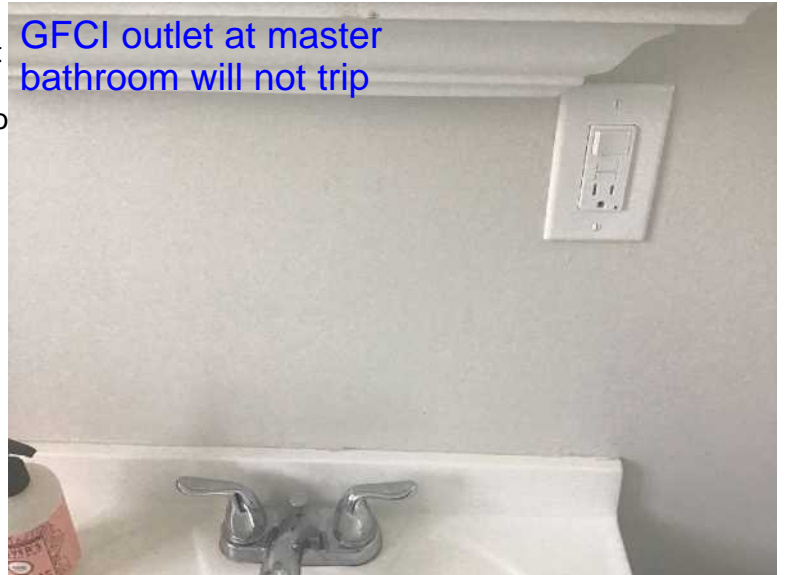
Rec. Evaluation GFCI: Kitchen and bathrooms, Not functioning - bathroom - GFCI outlet at the master bathroom does not trip when tested. This is presumably due to reversed wiring or an open ground being present at this outlet. Recommend evaluation by qualified contractor to determine best course of re-wiring and/or grounding any outlets in need. Once outlet is repaired, please also test for proper operation of GFCI safety function by pressing the "reset" button to ensure that outlet trips on and off properly.

GFCI outlet at master bathroom will not trip

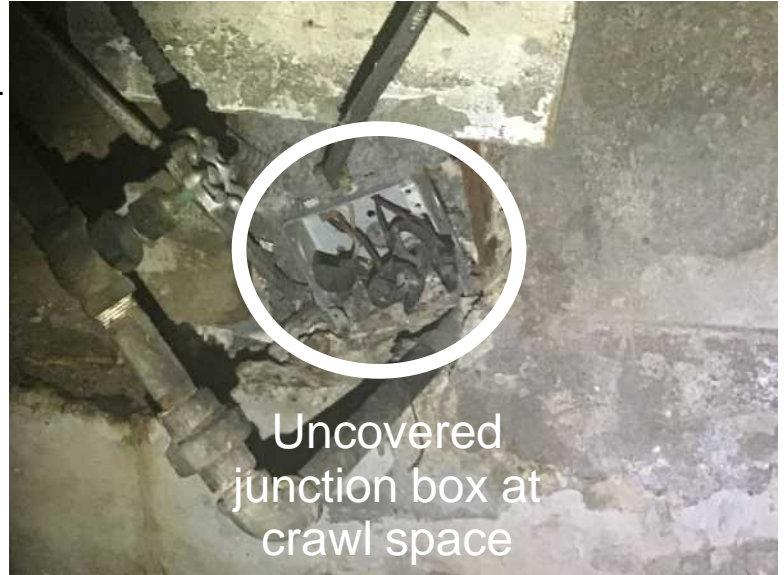
Rec. Evaluation Miscellaneous: Uncovered junction box
- There is an uncovered electrical junction box present in the crawl space. Recommend that this junction box be covered with a properly rated cover in order to protect the wiring inside.

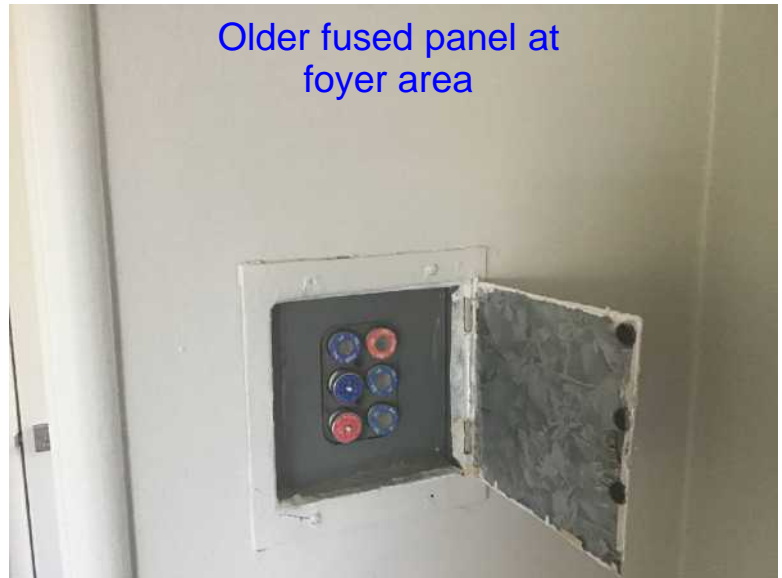
Recessed in wall, Foyer Electric Panel

Acceptable Manufacturer: Unable to determine due to lack of sticker
Not Inspected Max Capacity: Unable to determine due to lack of sticker
Acceptable Panel Cover: Metal, Intact, No Issues Detected
Marginal Fuses: Screw type - The wiring/electrical components are currently being protected by fuses rather than circuit breakers. Fuses are no longer used for this type of protection and this panel should ultimately be upgraded to included circuit breaker protection in order to comply with current industry standards.

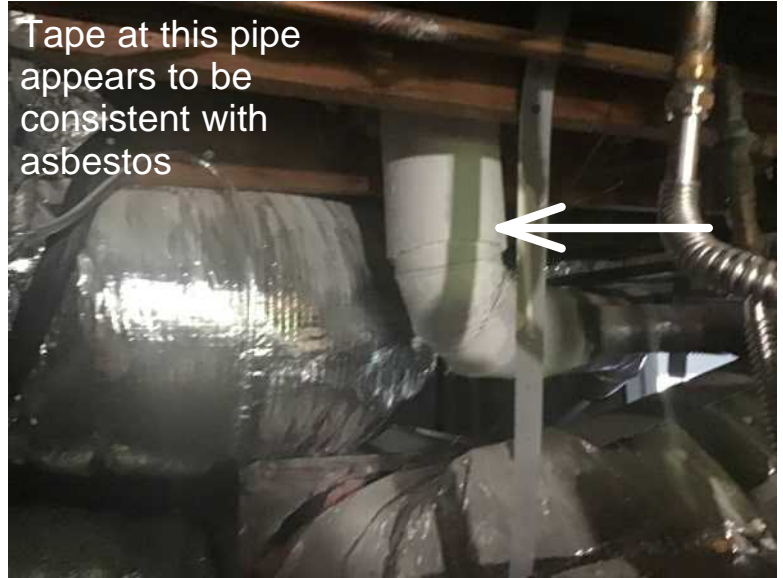
Distribution: Ducts and registers
Flue Pipe: Double wall, Type B, Metal - The tape/insulation being used at the older section of flue pipe appears to be consistent with types that have been known to contain asbestos in the past. The presence of asbestos can only be fully determined through laboratory testing. This type of asbestos is only considered hazardous if fibers become loose and inhaled...which is unlikely in this type of setup. However, if children will be present in the home, it is advisable to ultimately have the home tested for asbestos.

Tape at this pipe appears to be consistent with asbestos

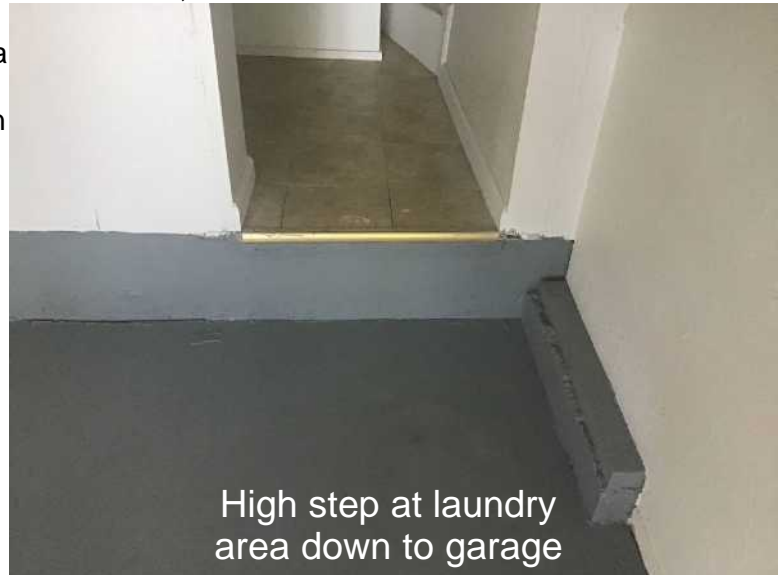
Acceptable	Service Line: Copper
Acceptable	Water Pressure: Functional
Acceptable	Main Water Shutoff: Front of house
Acceptable	Supply Lines: Copper
Acceptable	Drain Pipes: ABS
Acceptable	Kitchen Sink: Stainless Steel, Single bowl with sprayer
Acceptable	Bathroom Sink/Basin: Molded dual bowl (guest bath), Molded single bowl (master bath)
Acceptable	Faucets/Traps: Metal fixtures with ABS traps, Metal fixtures with PVC traps
Acceptable	Tub/Surround: Porcelain tub and ceramic tile surround, Shower over tub
Acceptable	Toilets: Glacier Bay
Acceptable	Shower/Surround: Tile pan and ceramic tile surround, Glass door/front
Monitor	Miscellaneous: High drop off - Please note that the step from the laundry area down to the garage area is higher than is typical. Caution should be used when using this area or another small step should be added.

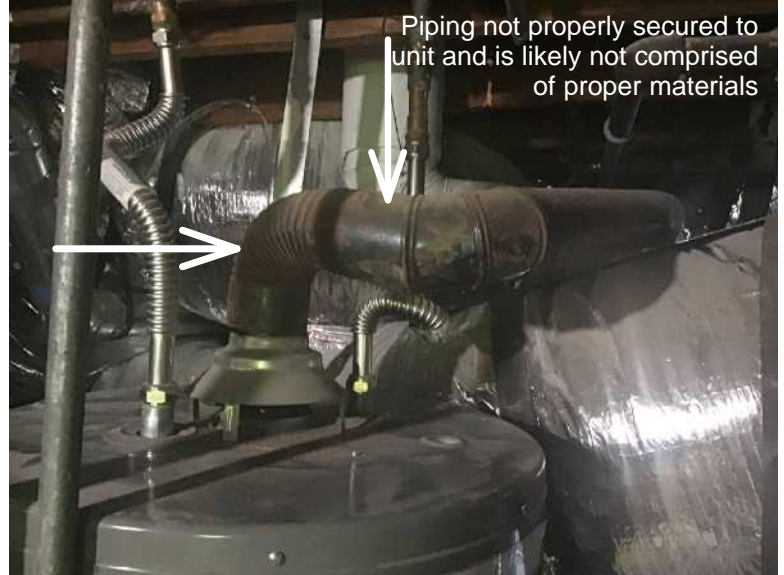
Flue Pipe: Metal - The piping is not properly secured to the top of the unit and also appears to not be of galvanized steel double wall material, commonly called upon the current industry standards. Recommend replacing the pipe with a properly rated one and having it properly secured to the unit.

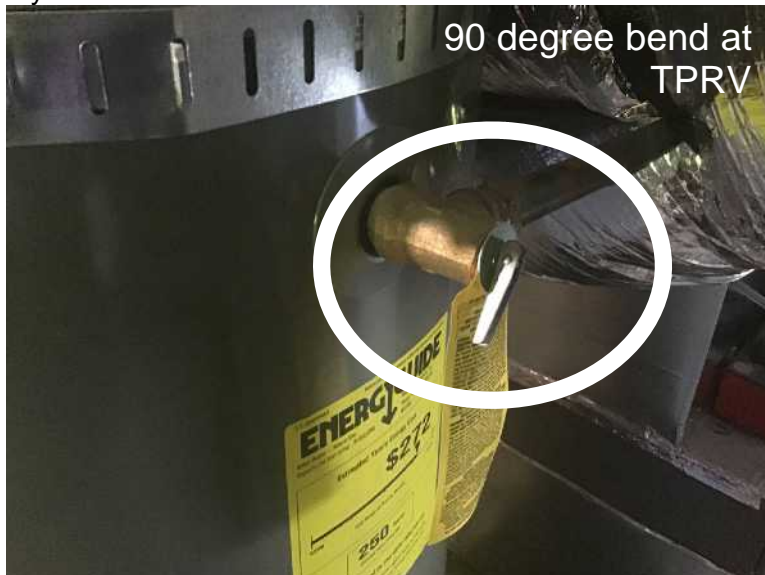
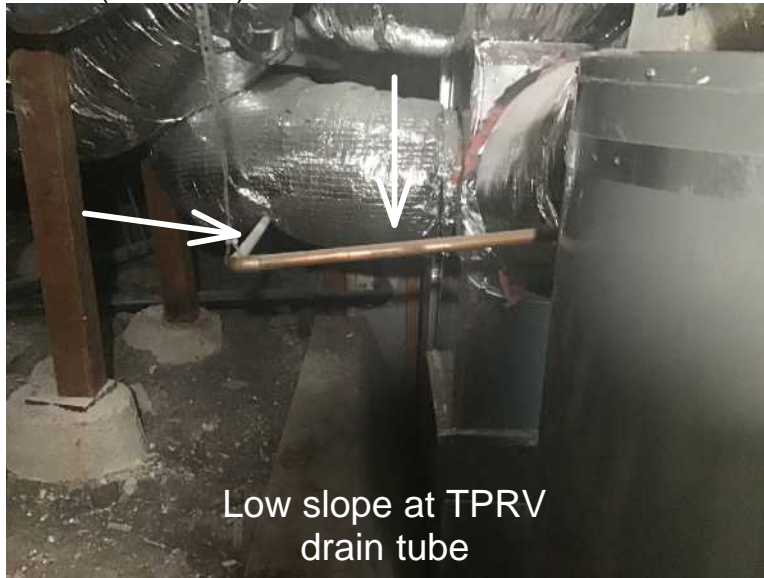
TPRV and Drain Tube: Copper - The TPRV currently takes a 90 degree bend shortly after leaving the unit. Its drain tube also has a very narrow slope exiting toward the exterior of the home. Recommend that this piping face directly downward and terminate within 6 inches of the crawl space floor.

A temperature and pressure relief valve (TPRV) is a safety valve that releases excess pressure from the water heater in the event the regulator fails. It is an important safety device that can prevent a dangerous explosion. Hot water may occasionally drip or spray from the valve discharge pipe, triggered by changes in water pressure. Leaky valves may fail from encrusted mineral residue, and should be replaced. Most TPRV manufacturers recommend the valve be tested once a year.

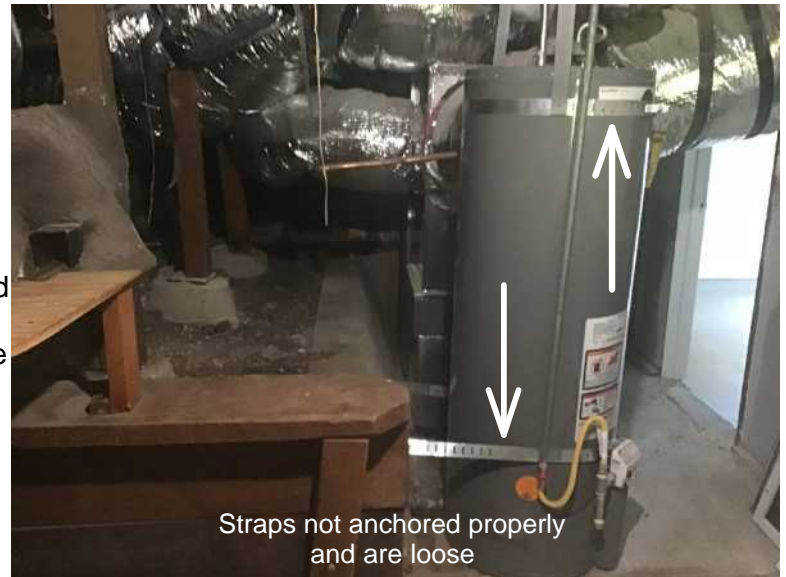
Seismic bracing Water heater is properly braced in accordance with current CA industry standards - Seismic straps at the water heater are not currently anchored in accordance with current industry standards. They should be re-situated so as to anchor into adjacent wood framing members. These straps are also slightly loose and are in need of tightening since the unit does wobble excessively with moderate force. The straps should be tightened or re-situated so that the unit will not wobble in the event of an earthquake.
