Safe at Home Inspection Service LLC

HOME INSPECTION REPORT

4413 Madeira Rd
Pleasant Hill, CA 94123

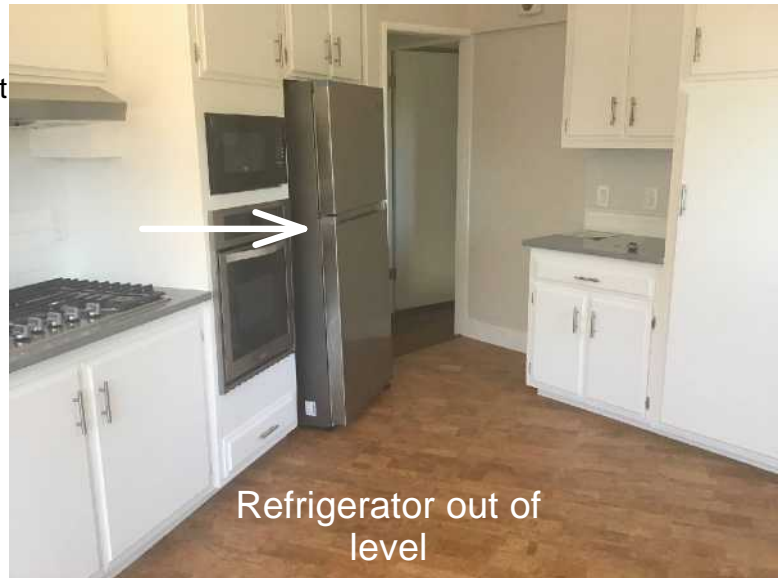
Rec. Evaluation Refrigerator: Samsung, Functional at time of inspection, New unit - The refrigerator is currently out of level, as it leans toward the back. Recommend that the leveling devices underneath the unit be adjusted so that the refrigerator sits level.

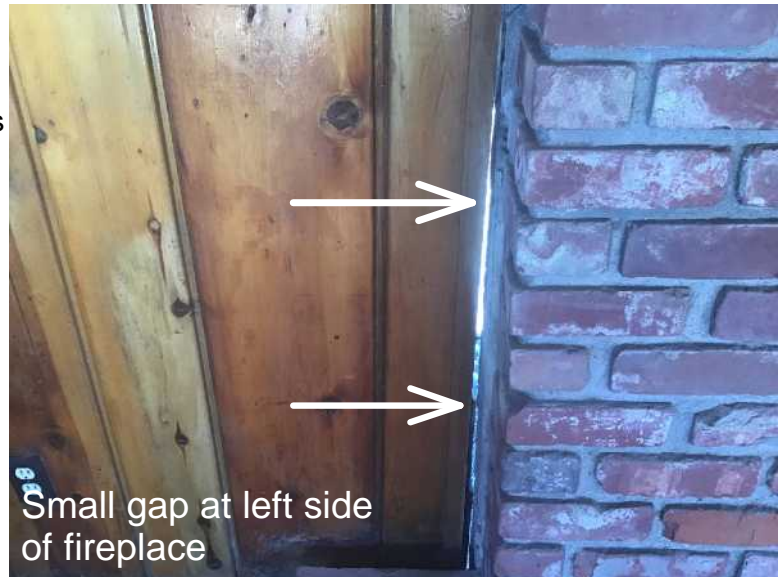
Rec. Evaluation Miscellaneous: Small gap - There is a small gap at the left side of the fireplace that is currently acting as a potential pest/moisture entry point. This job should be properly sealed to mitigate these conditions.

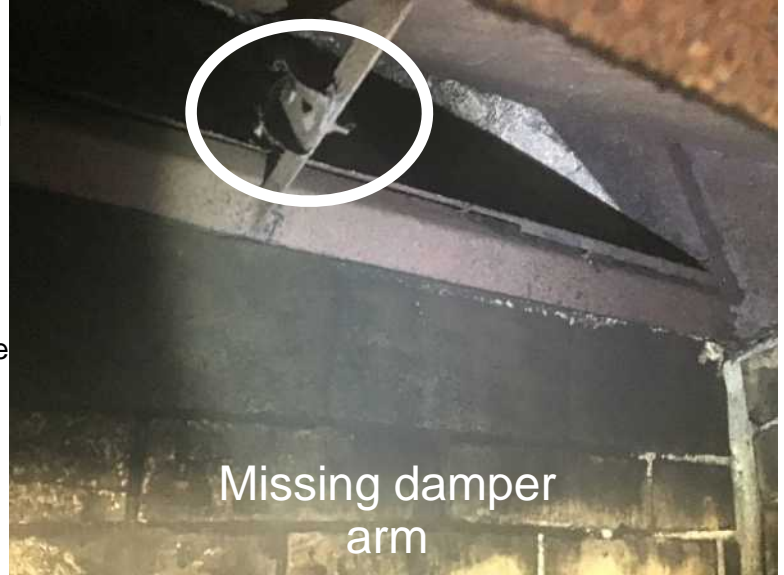
Damper: Metal - The fireplace damper is stuck in the open position. This will likely result in excessive drafting and loss of heat at this area. This condition is caused because the arm to the damper is currently missing. Recommend the installation of a new damper arm if this function is desired going forward. Please note that an operational damper is not required at this unit since it is located at the outside of the home.
